# Manhole Inspection Summary

Manhole # S47C\_\_013MH

Insp Date: **7/15/08 9:08 AM**

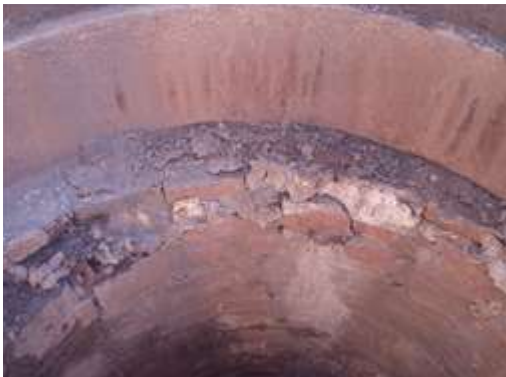
Defect 1

Condition: ☐ Sound ☐ Cracked ☐ Root Intrusion ☒ **Loose Brick** ☐ Deteriorated

loose brick

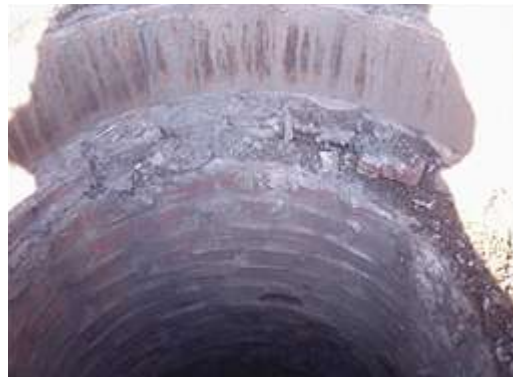
Defect 2

Infiltration: ☐ None ☒ **Joint** ☐ Cracks ☒ **Mortar** ☐ Roots ☐ Wall

infiltration

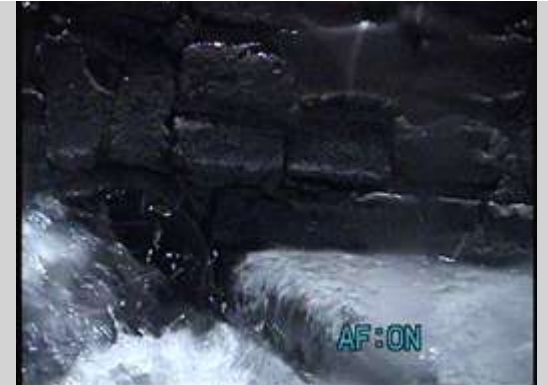
12 O'Clock Outflow

8 in. Circular Gravity Sewer  
Pipe Out @ 12 O'Clock

Pipe Height: **8.4** (in.) Rod and Bar (Angled)  
Pipe Material: **Clay** ☐ Pipe Lined  
Invert Depth: **14.25** (ft.) Flow Characteristics: **Turbulent**  
Deposits: ☒ None ☐ Mud ☐ Sludge ☐ Debris ☐ Grease  
Silt Depth: (in.) Deposits Extent:  
Infiltration: **None** Pipe Seal Cond: **Sound**

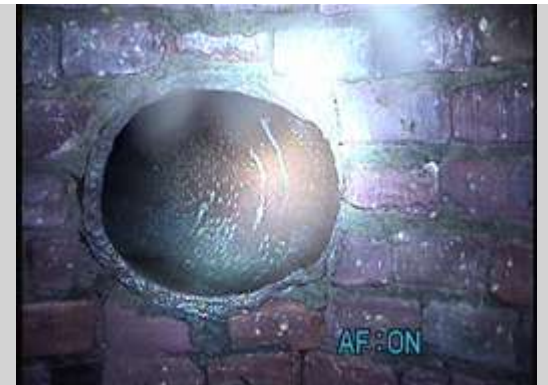
6 O'Clock Inflow

8 in. Circular Gravity Sewer  
Pipe In @ 6 O'Clock

Pipe Height: **8.4** (in.) Rod and Bar (Angled)  
Pipe Material: **Clay** ☐ Pipe Lined  
Invert Depth: **10.50** (ft.) Flow Characteristics: **Turbulent**  
Deposits: ☒ None ☐ Mud ☐ Sludge ☐ Debris ☐ Grease  
Silt Depth: (in.) Deposits Extent:  
Infiltration: **None** Pipe Seal Cond: **Sound**

Drop: **Inside** Rod and Bar  
Angled: **Yes** Reading: **13.15** (ft.)  
Inv Depth: **14.15** (ft.)

Drop Condition: **Open**
